TROUBLESHOOTING ICP SPECTROMETERS

Glass Expansion February 2014 Newsletter, “Troubleshooting Guide for ICP
Optical Emission Spectrometers.”

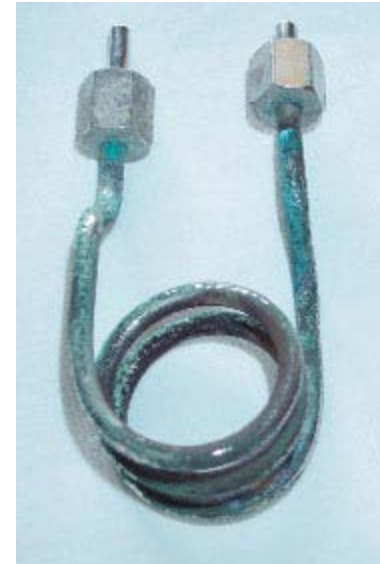
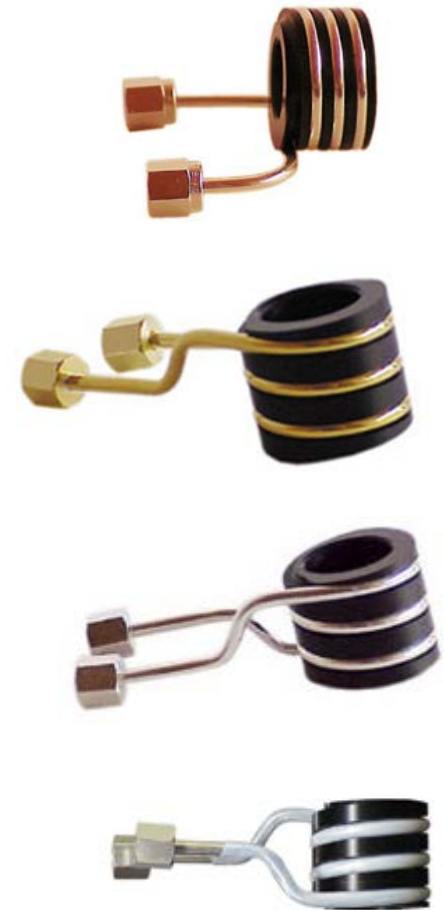
GE RF Coil

RF Coil

- Regular replacement of corroded coils reduces the load on the RF generating system
- Changing corroded coils increases energy transfer, resulting in a more robust plasma and generally higher analytical line intensities
- Reduce chance of arcing

- Unique plating process
- Coil former, protects and maintains spacing
- Do-it-yourself installation tool

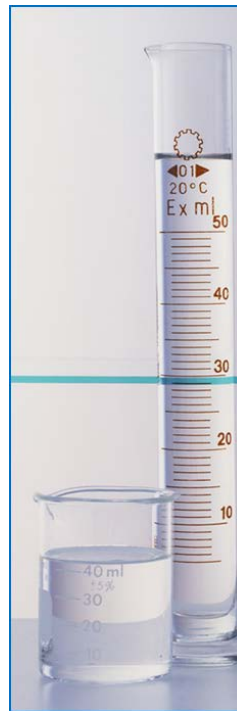
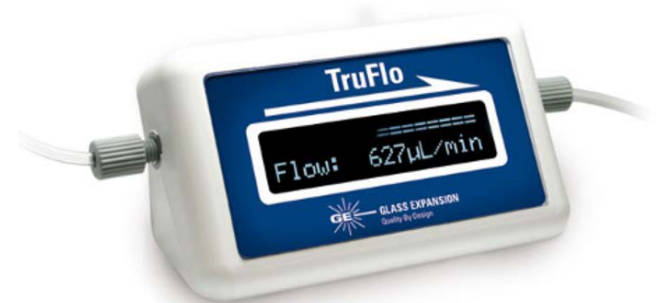
TruFlo P/N: 70-803-0643

Volumetric measurement Vs Real-time continuous measurement

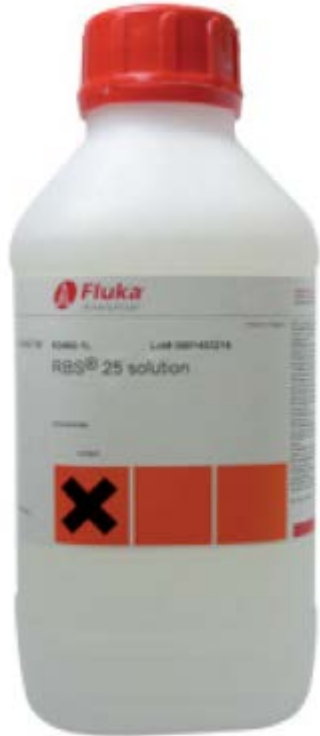
Clogged Nebulizer

1. Flush your nebulizer with warm water using the Eluo.
2. Soak the nebulizer tip in a 25% solution of Fluka for 24 hours. Use the Eluo to make sure the Fluka solution fills the nebulizer.
 - An initial flush of 25% Fluka using the Eluo may be required.
3. Flush 3 times with warm water using the Eluo.
4. Stubborn deposits may require an additional soaking for 2 hours with 5% nitric acid.
5. Flush 3 times with warm water using the Eluo.
6. For faster drying, flush again with methanol.

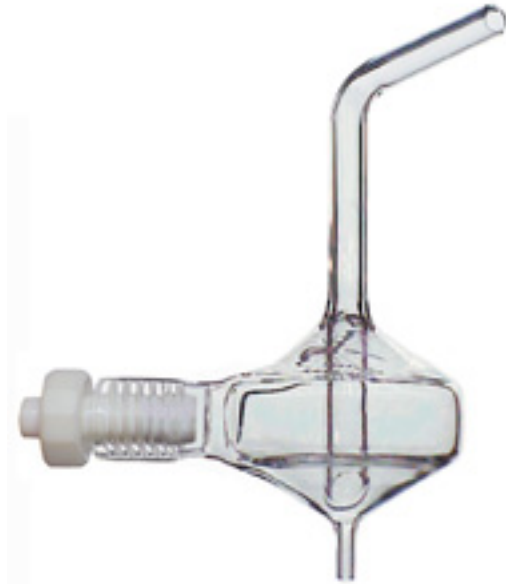
SPRAY CHAMBER NOISE

- Blocked drain line
- Worn drain pump tubing
- Dirty spray chamber surface (clean with Fluka)
- Droplet buildup on transfer tube (axial or DV)

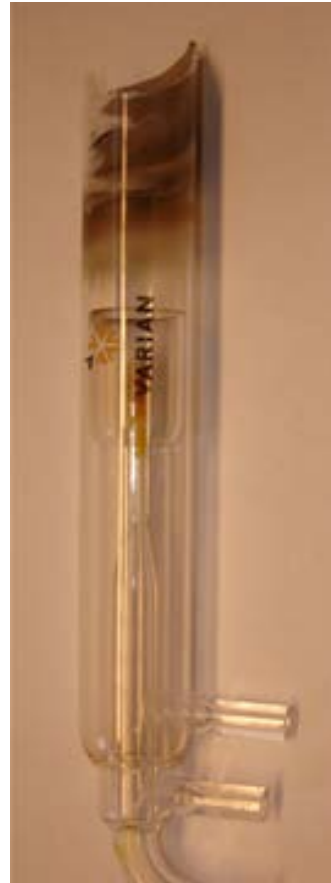
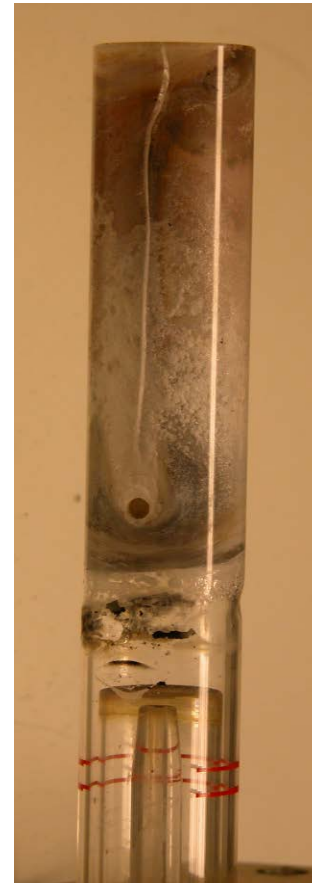
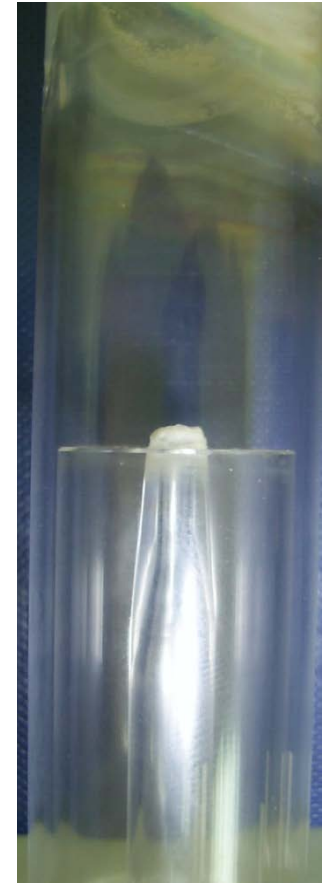
TORCH ISSUES

- Torch alignment
- Injector alignment
- Torch condition
 - Devitrification
 - Coil concentricity

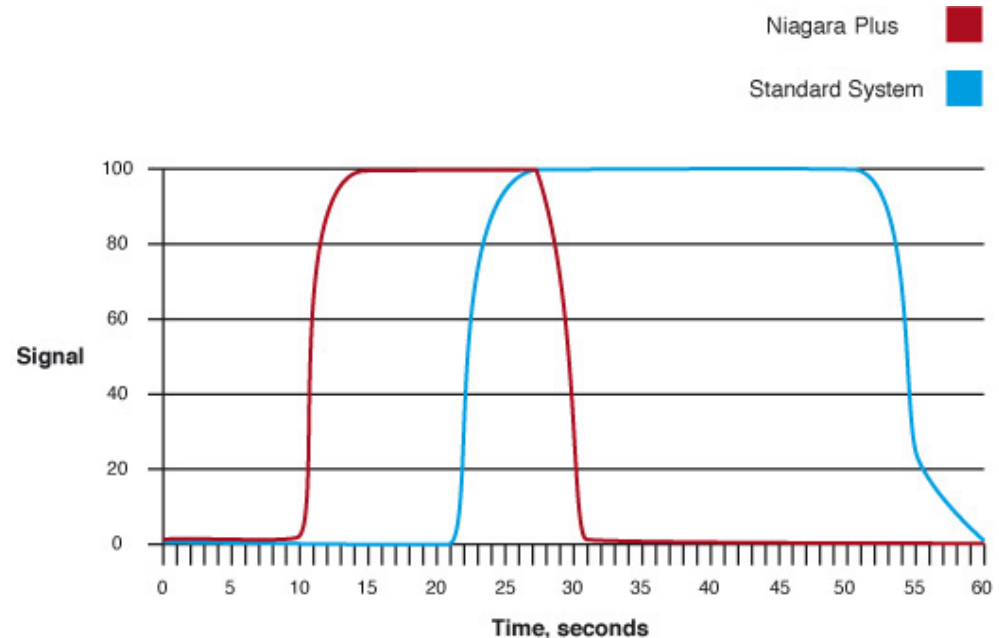
WASHOUT

- 0.1% is typical goal
- Run 100ppm standard
 - < 0.1ppm on subsequent blank
- Varies between elements
- Rinse time and solution
- Switching valve-Niagara Plus CM

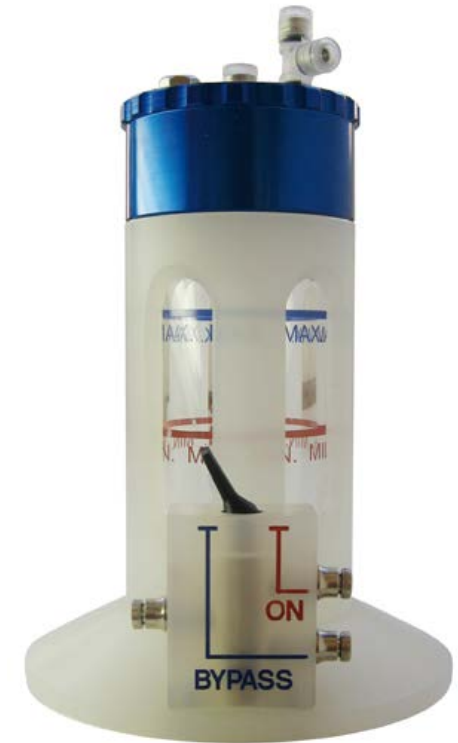
CAUSES OF LONG-TERM DRIFT

- Build-up on nebulizer tip - up or down
- Build-up on injector tip - usually down
- Room temperature drift - IsoMist
- Faulty gas regulator or MFC
- RF system-use Ar I 404test
- Optics - UV lines more severe
- Detector - use BKG test at 190
